Turfgrass Color

An Indicator of Septic System Performance

Brad D. Lee and Gregg C. Munshaw, Plant and Soil Sciences

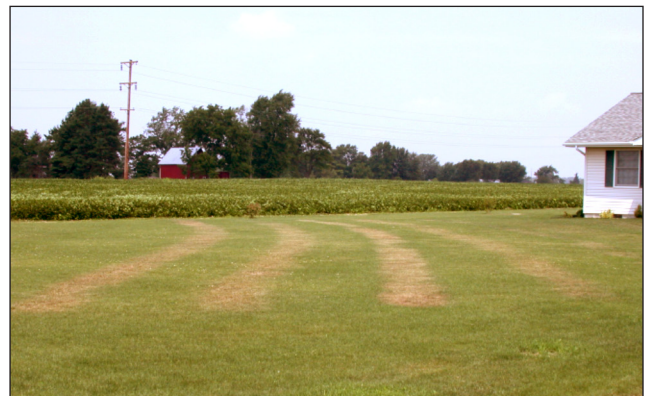
Figure 1. Brown turfgrass over soil absorption field trenches indicates an absorption field that is probably functioning as designed.

In warmer months or during dry periods, turfgrass over subsurface soil treatment areas can turn brown and appear burned (Figure 1). This condition is due to the lack of water-holding capacity in soil above the absorption field trenches or beds.

Brown turfgrass over the septic system is merely an aesthetic problem. **No action is required by the homeowner.** Your septic system is probably functioning as designed. The problem is transient, and your lawn should recover fully by October when the temperatures cool and it rains. You should not water your lawn above the absorption trenches because the additional water can reduce the effectiveness of the soil treatment area and may eventually lead to soil treatment area failure.

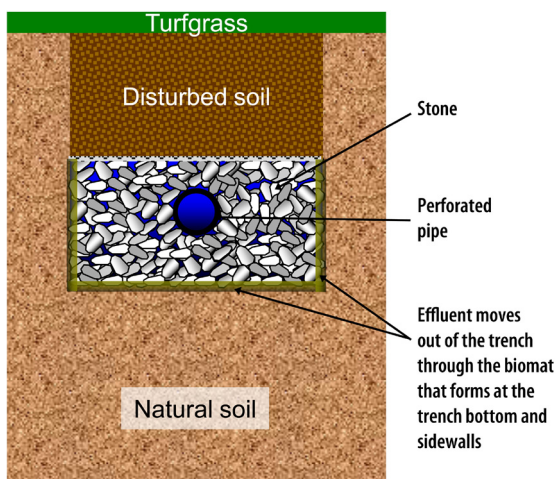
Cross Section of Soil Absorption Field Trench

A cross section of a typical soil absorption field trench. A foot of gravel surrounds a perforated pipe at the bottom of the trench. A geotextile fabric is placed on top of the gravel to prevent soil from filling in the spaces between the stone. The remainder of the trench is filled with soil to the original surface grade.

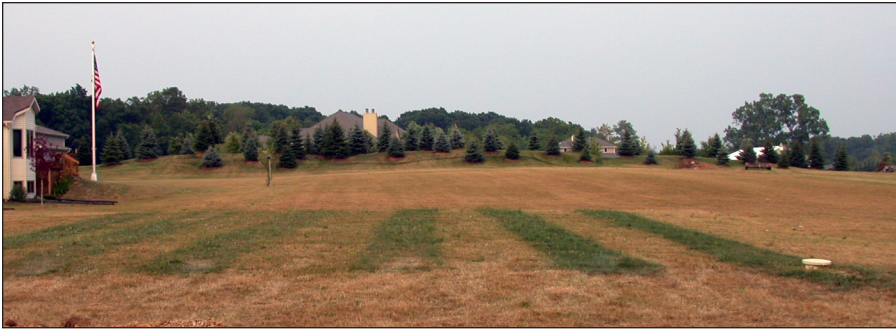
Figure 2. Unusually green turfgrass stripes represent a stressed septic system that is failing or likely to fail during wetter months or when the system receives high wastewater flows.

When a septic system soil treatment area overloads hydraulically, the trenches are filled with wastewater. Hydraulic overloading occurs when the soil surrounding the trenches cannot absorb and disperse high wastewater flows produced by the home. When the soil cannot absorb and disperse all the wastewater, the trench fills like a bathtub. The nutrient-rich wastewater moves through the soil pores above the trenches to the surface, resulting in lush green turfgrass over the absorption field. In dry months, the green stripes over the trenches offer a stark contrast to the grass between the trenches (Figure 2).

If you have properly maintained your septic system over its lifetime and you observe green stripes over the soil absorption field during extended dry periods, decrease the load on the system by:

If you decrease water use but green turfgrass stripes persist for a few months, contact your county health department for additional advice. These health professionals will have a list of septic system professionals in your area who can assist in troubleshooting your problem. Possible solutions include adjusting flows in your septic system distribution box or adding additional trenches to an
